# **Aviation Maintenance Alerts**

**AC No. 43-16A**

**ALERT NO. 261  
APRIL 2000**

**Improve Reliability-  
Interchange Service  
Experience**

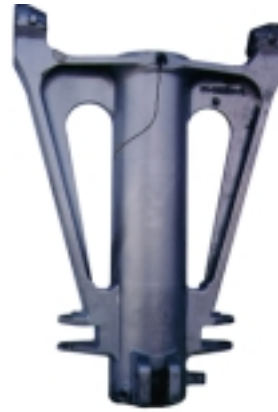
**Beech; Model BE-65-A90; King Air; Nose Landing Gear Brace Assembly Damage; ATA 3222**

During a postflight inspection, the technician discovered a crack in the nose landing gear brace assembly.

The crack extended from the lubrication hole at the top of the brace assembly (P/N 50-820204-3) and curved down approximately 11 inches. (Refer to the following illustration.) The submitter determined this was an "older" style brace assembly. Improper servicing, hard landings, or other abuse may have caused this defect.

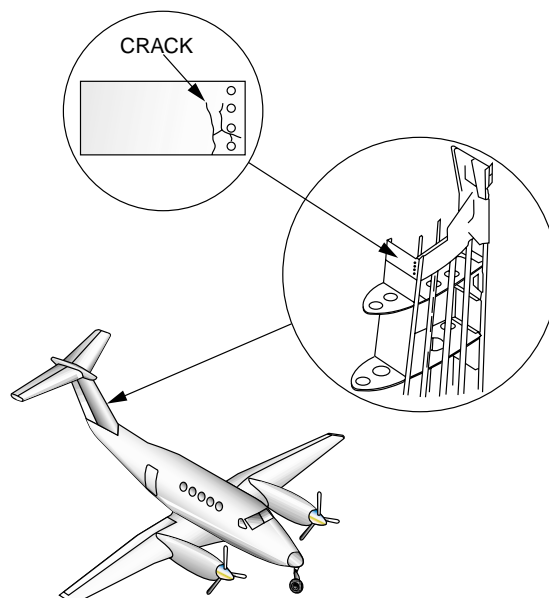
### **Beech; Model 200; King Air; Empennage Structural Defect; ATA 5553**

After removing the vertical stabilizer leading edge to accommodate an inspection, the technician discovered the left horizontal stabilizer attachment fitting was cracked.

The fitting (P/N 101-640012-3) is used to attach the horizontal stabilizer to the top of the vertical stabilizer front spar. It appeared the crack originated from the bottom "huck bolt" hole, migrated upward along side the next

"huck bolt," and spread out in four directions. (Refer to the following illustration.) The submitter did not offer a cause for this defect.

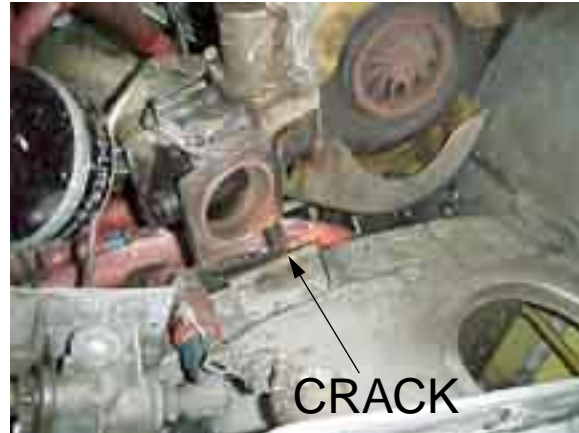
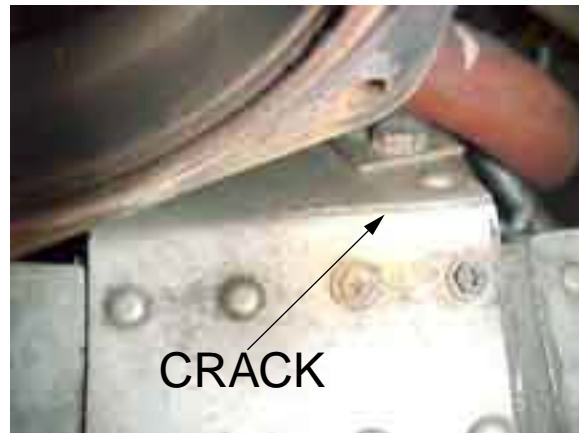
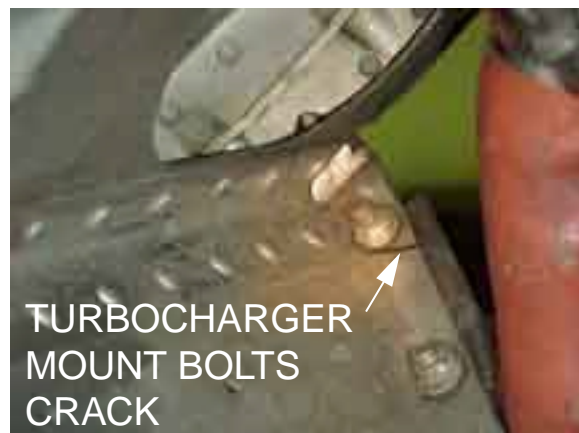
**Cessna; Model 421C; Golden Eagle; Engine Mount Beam Cracks; ATA 5410**

During an annual inspection, the technician discovered a crack in an engine mount beam.

The engine mount beam (P/N 5054030-42) in the left engine nacelle was severely cracked and in danger of failure. (Refer to the following illustrations.) Also, the submitter found the same discrepancy on the right engine mount beam.

The FAA, Service Difficulty Reporting Program data base contains seven additional entries involving structural defects associated with the engine mount beam assembly. All operators and maintenance personnel are advised to check the engine mount beams closely at every opportunity.

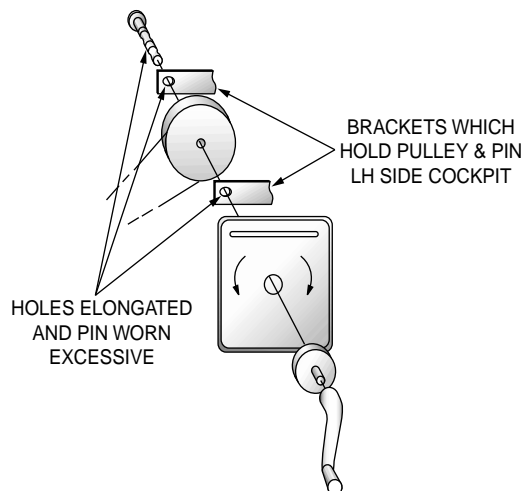
**PIPER****Piper; Model PA12; Super Cruiser; Defective Elevator Trim Control; ATA 2731**

During an annual inspection, the technician found the elevator trim control in the cockpit displayed excessive free play. When operated, the trim control would bind at various points in its travel.

Further investigation disclosed the elevator trim pulley and shaft were worn excessively into the support brackets. The holes in the support brackets were severely elongated, and the shaft was worn. (Refer to the following illustration.) Give this area special attention during scheduled inspections and maintenance.

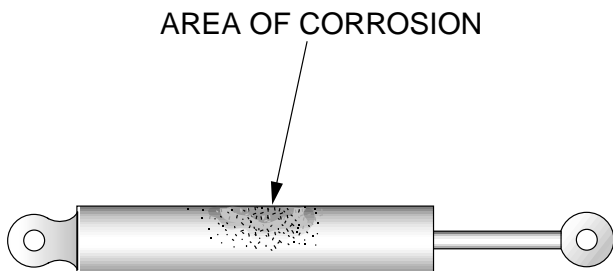
**Piper; Model PA23-250; Aztec; Main Landing Gear Hydraulic Leak; ATA 3233**

When the fluid was cleaned, the technician found the actuator (P/N 350302) had pin holes in the body of the cylinder. (Refer to the following illustration.) The submitter determined the pin holes were the result of "intergranular" corrosion. The submitter did not give the origin or cause of the corrosion.

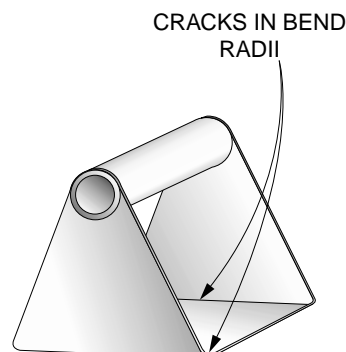
After investigating further, the technician found the rudder center crossbar support assembly (P/N 63451-00) was cracked. (Refer to the following illustration.) The rudder crossbar support cracks were located in the bend radii along the lower edge. Excessive rudder pedal input, metal fatigue, and mild corrosion may have caused this damage.

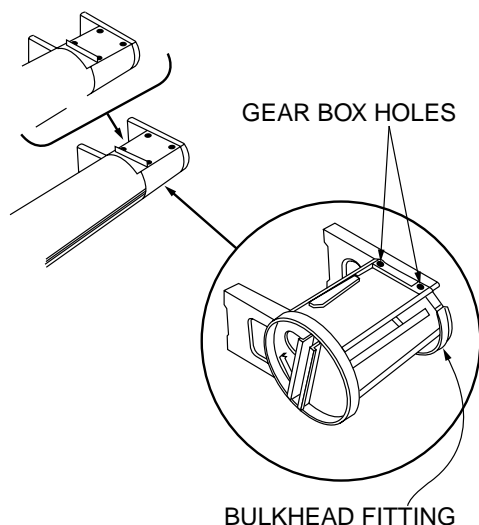
**Bell; Model 206BIII; Jet Ranger; Tail Boom Structural Defects; ATA 5500**

During a 100-hour inspection, the technician discovered structural defects in a fitting attached to the aft tail boom bulkhead.

The tail boom bulkhead (P/N 206-030-446-001F) fitting cracked at an attached fitting used for mounting the tail rotor gearbox. (Refer to the following illustration.) The aft upper fitting holes were severely cracked. It appeared the cracks developed at the aft tail rotor mount

holes and migrated to adjacent rivet holes. The technician found cracks on the top of the fitting which were not visible when the fitting was installed.

The submitter speculated that this damage was caused by undertorque or overtorque of the hardware during installation or excessive tail rotor vibration.

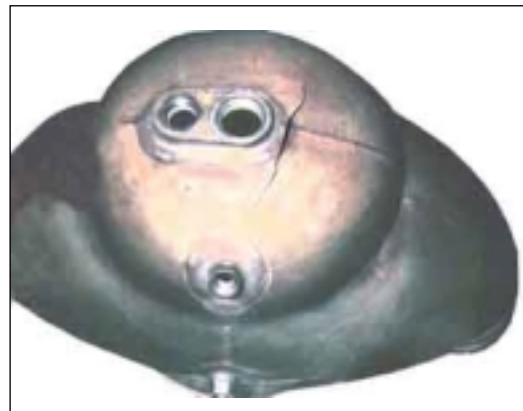
After changing the bleed air valve and checking the anti-ice system for proper closing of the valve, the technician found the problem was still present. An engine operational test revealed a substantial power loss which prompted removal and disassembly of the engine. While examining the engine, a technician discovered a crack approximately 3 inches long in the combustion case (P/N 6870992). (Refer to the following illustration.) The crack was located on the back of the combustion case adjacent to the fuel nozzle. The cause of this defect is presently under investigation and will be reported in a future edition of this publication when it is available.
